GUI Version 3.6

1 Overview

FIRECLASS TIB 1231 TECHNICAL INFORMATION BULLETIN

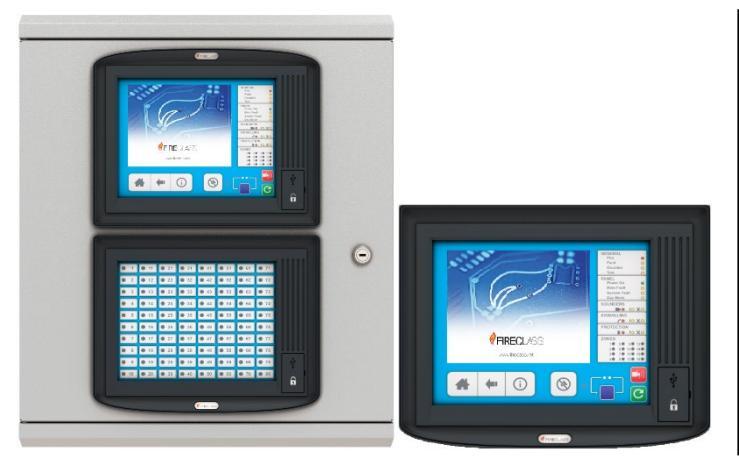
The FireClass FC700 range includes:

- FC708D
- FC718D
- FC702S
- FC702D
- FC1DS/FC8AS (Ethernet based repeaters)
- FC1D2 (RS-485 based repeaters)

The FireClass GUI is available as the primary user interface within the enclosure of the FireClass FC700 range of fire alarm control panels. The FireClass GUI is also available as a repeater on the FireClass panels.
